Attachment I

State Road 512 Summary of Maintenance Issues

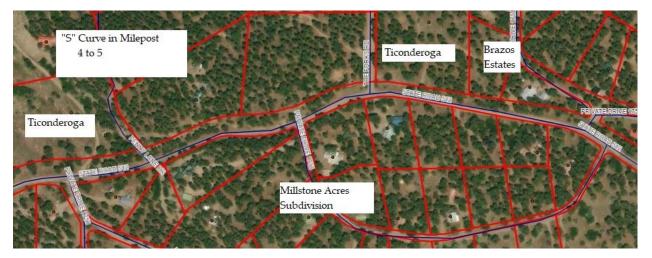
S Curve Properties

About midway up 512 to the cliffs, the road passes through a narrow "S" curve where drivers turn white knuckled as they maneuver past each other. The "S" curve is tight with trees growing up to the edge of the pavement, leaving little room for driver error. Last winter a DOT driver slid his plow truck into the adjacent narrow ditch, blocking the road for several hours. With 250 fulltime residents in the Brazos canyon, this is an unacceptable hazard and a solution must be found. It can only be stated again that since 512 is the sole evacuation route, this portion of the roadway must be dealt with or seriously loss of life and property will occur.

Solutions to the S curve may be able to occur in NMDOTS existing ROW or may require an additional 2.4 property owners.

This is obviously a safety issue and needs to be properly address in the DOT planning process starting with an up-to-date survey, correct ROW dimensions, and property boundaries.
